Satellite Remote Sensing for Landslide analysis

A Multi-sensor And Multi-variable Satellite Observation Approach For Investigating The Reactivation and Failure Of An Old Landslide In North Central Iran Following Reservoir Impoundment

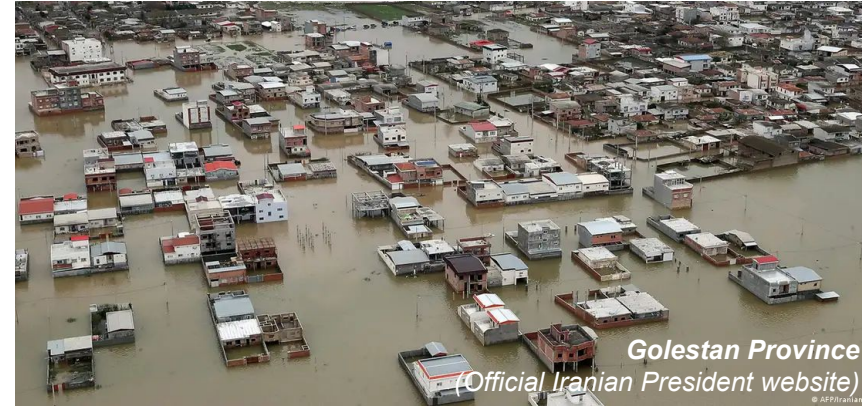
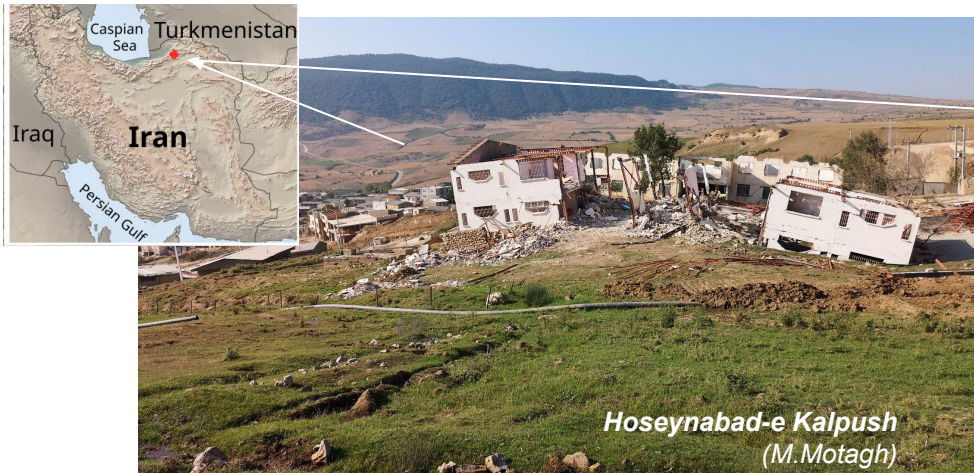
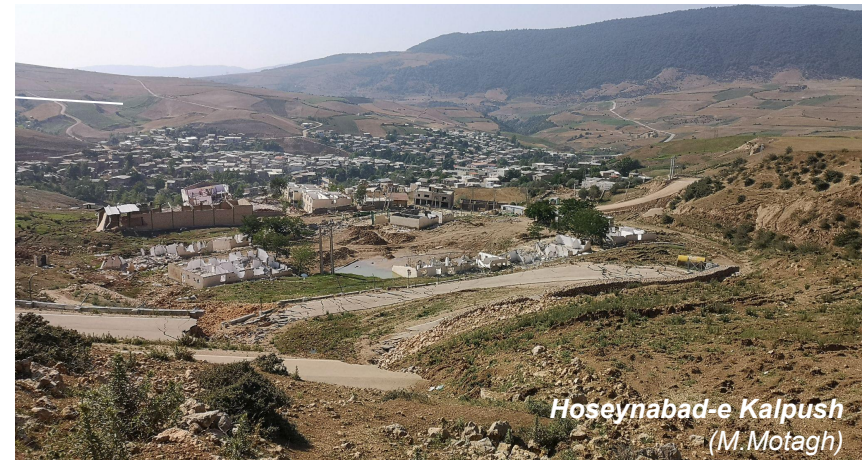
March-April 2019 intense record rainfall over almost the whole Iran;
Flash floods and **thousands of slope failures** causing fatalities and damages;
Landslide collapse in Hoseynabad-e Kalpush village (north-east Iran);
Hundreds of houses damaged or destroyed.

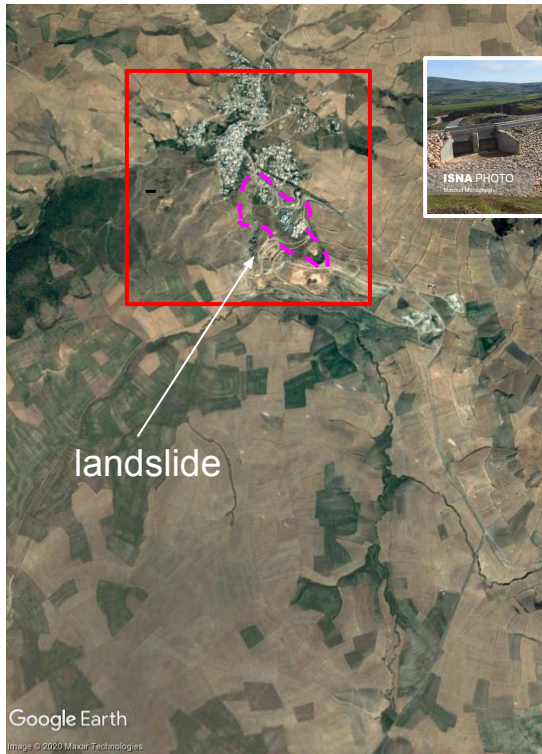
©Google image 2010

©Google image 2019

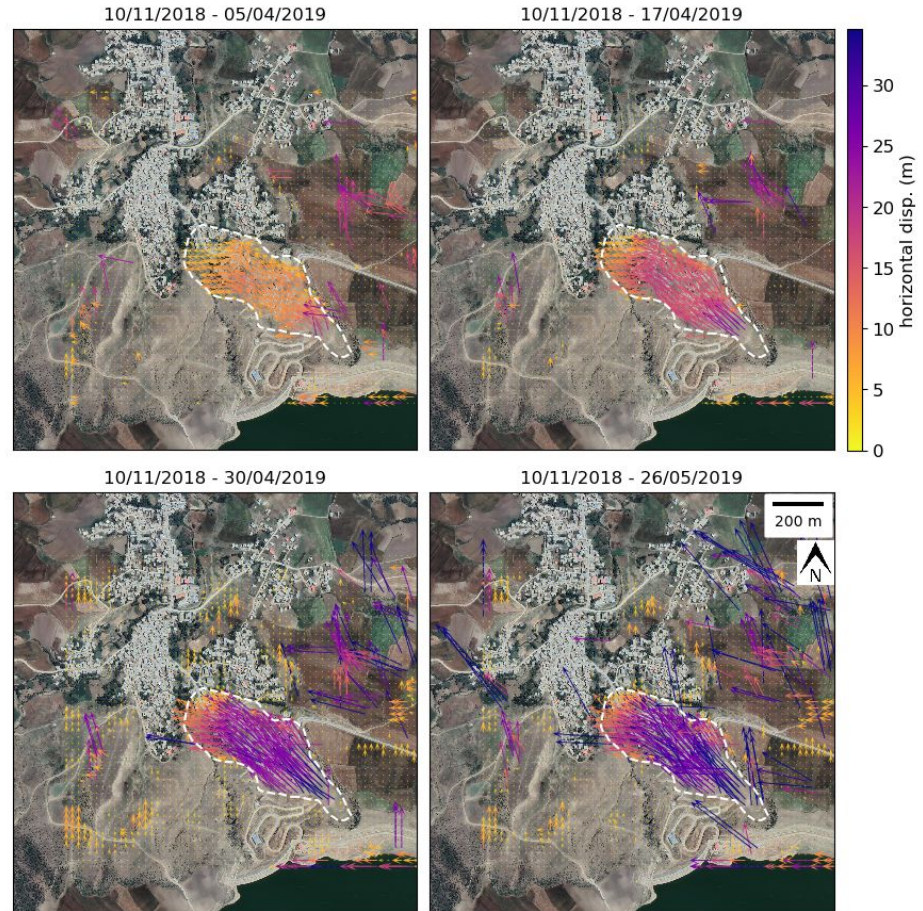
Co-failure ground displacement

PlanetScope (3m resolution) time series
11.2018-06.2019

Deep-seated landslide failure;

Rupture scarp on the top and deposited
mass on the bottom;

Horizontal offset higher than 40m on the
upper part;

Up to 8 m on the lower part.

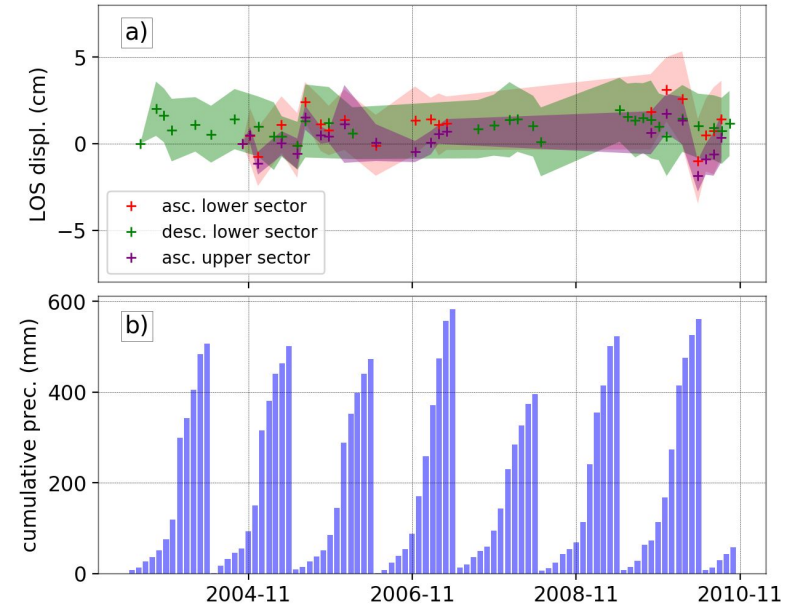
Pre-failure ground displacement

Envisat dataset Sept. 2003 - Sept.2010

LOS ground displacement

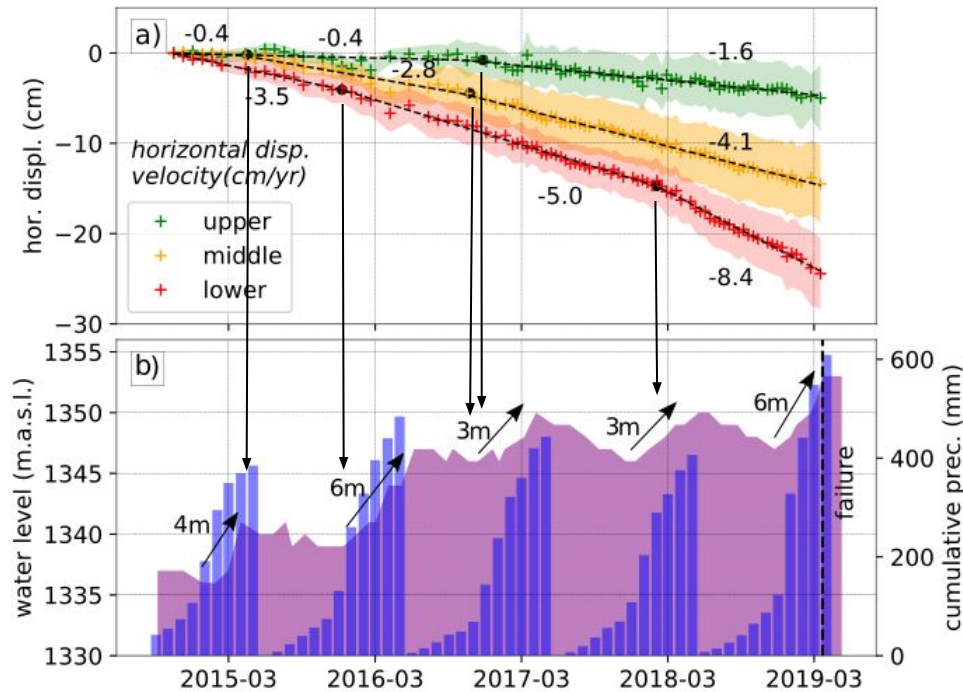
Horizontal component

Nearly linear trends increasing with time;

The lower part was already moving at the end of 2014 (the water level was **18 m**);

The middle part started to move around May 2015 (the water level was **22 m**);

The upper part started to move around January 2017 (the water level was **28 m**).

Retrogressive mechanism of destabilization;

Constantly acting external force (not a seasonal one) due to the water impoundment.

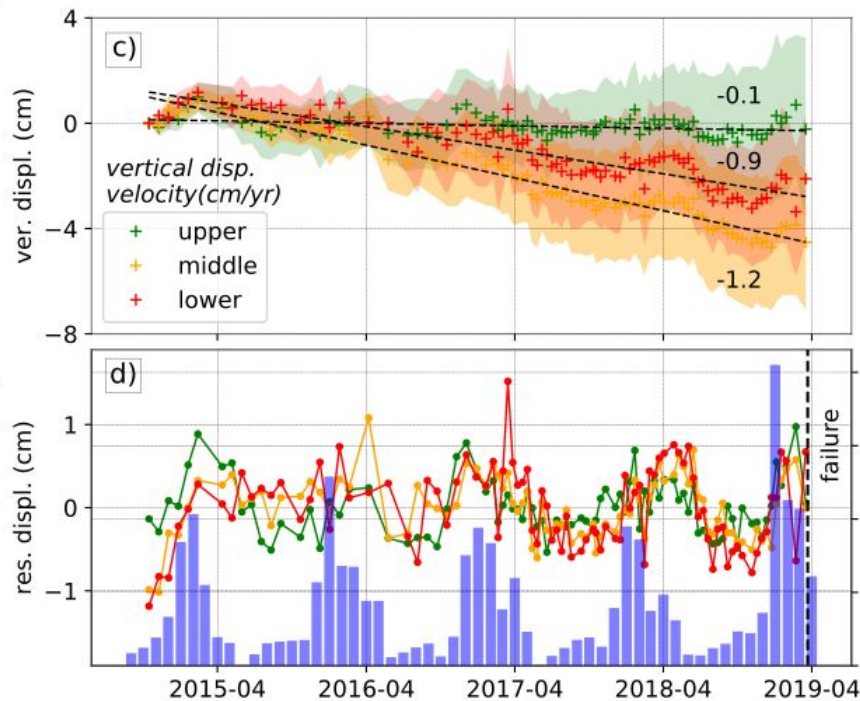
Vertical component

Small main linear trend;

Seasonal component that correlates yearly and in-phase with the monthly cumulative precipitation

Cross Wavelet Transform

Swelling and shrinkage of the shallower soil layer due to seasonal soil moisture change.
